N.S.W. PRE-PURCHASE INSPECTIONS

STANDARD BUILDING INSPECTION REPORT

ADDRESS OF PROPERTY:	<i>Address Deleted</i>
OWNER'S NAME:	<i>Name Deleted</i>
AGENT:	<i>Name Deleted</i>
GENERAL DESCRIPTION OF PROPERTY:	Original double brick house constructed on timber beam and pier flooring with a substantial brick veneer first floor addition and an extension at the rear exhibiting termite damage on the property and requiring a number of other repairs as detailed.
ACCOMMODATION:	Four bedrooms
AGE OF PROPERTY:	The original house is probably 80 years old
NEIGHBOURING PROPERTIES:	Houses of varying styles and ages
WEATHER CONDITIONS ON DAY OF INSPECTION:	Dry

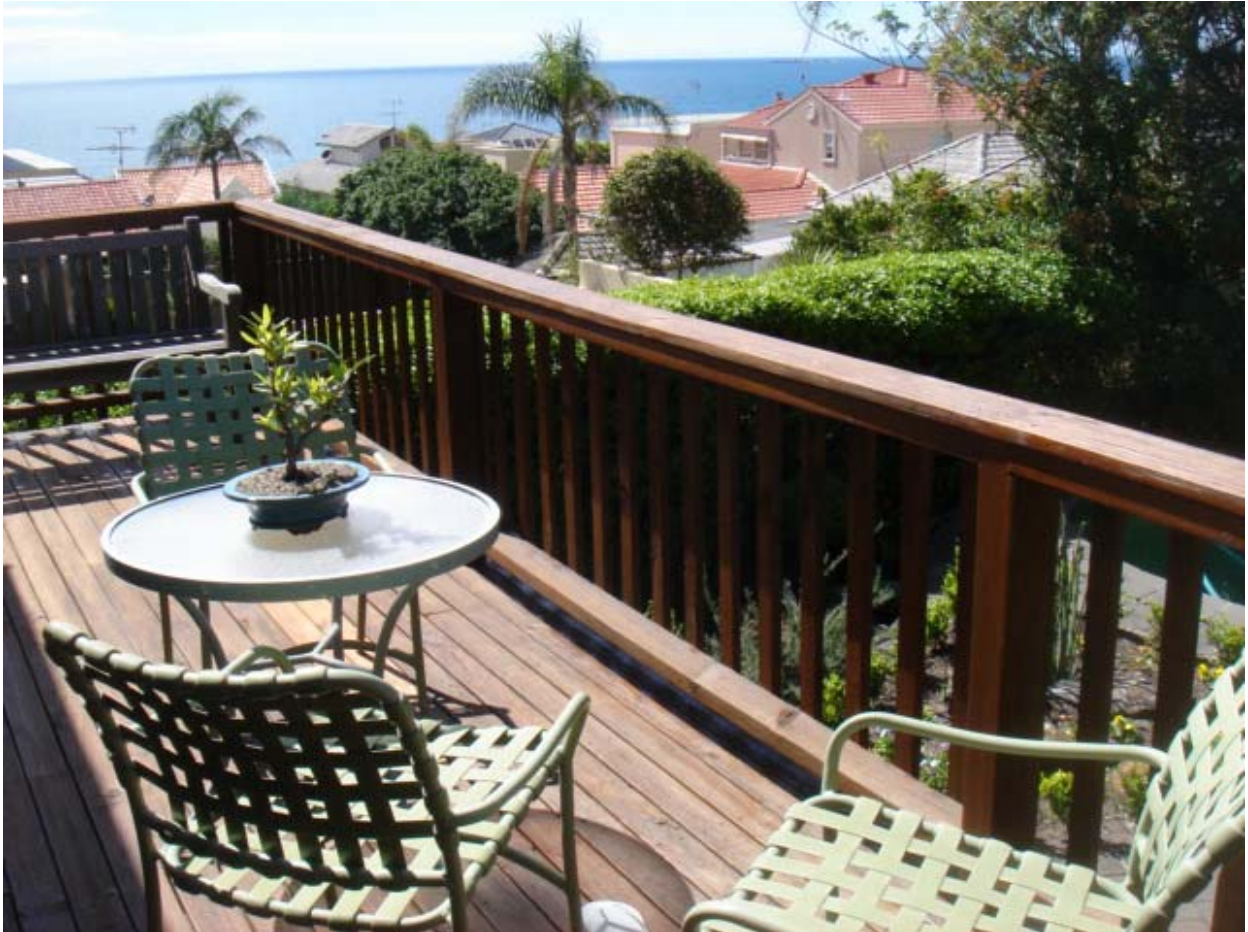
Photo 1.

4. Rails enclosing the balcony are approximately 920 mm above the floor and do not comply with Council regulations because the Building Code of Australia states that these rails should be 1 metre above the floor for safety purposes and replacement of the rails should now be undertaken. (See photo 1).

Rails enclosing the balcony are too low and do not comply with the Building Code of Australia for safety purposes.

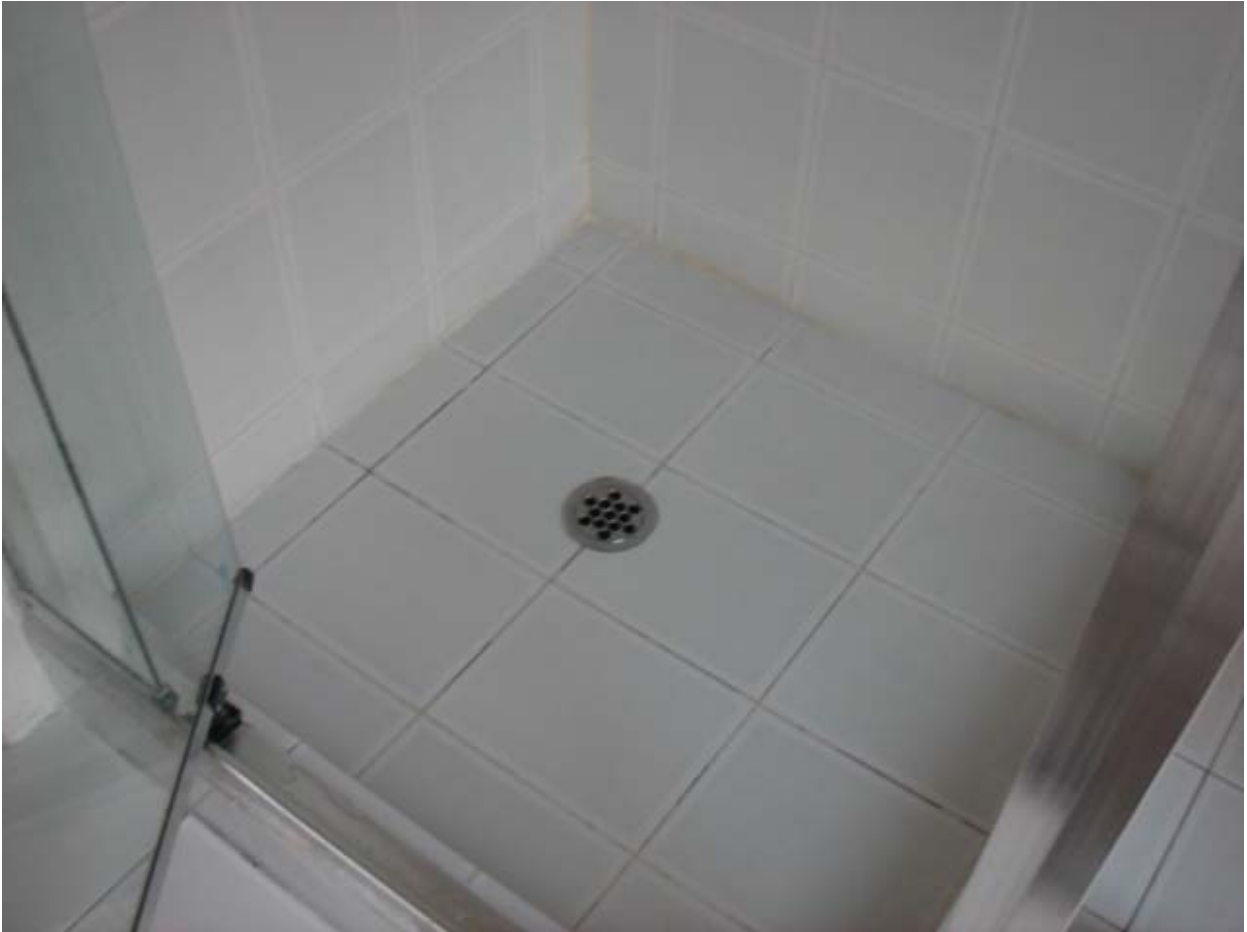
Photo 2.

11. Tiles in the shower enclosure in the en-suite bathroom are exhibiting wear and tear, a condition that may allow water penetration through the bathroom walls and floor and replacement of the tiles and renewal of the waterproof membrane would now be recommended with costs involved being in the order of \$1500. Furthermore, the continual penetration of water through the bathroom walls and floor may result in rotting of the timber wall and floor framing but any deterioration of the timberwork will only be visible when the ceramic tiles are removed and timber framework exposed to view. (See photo 2).

Tiles in the shower enclosure in the en-suite bathroom are exhibiting wear and tear.

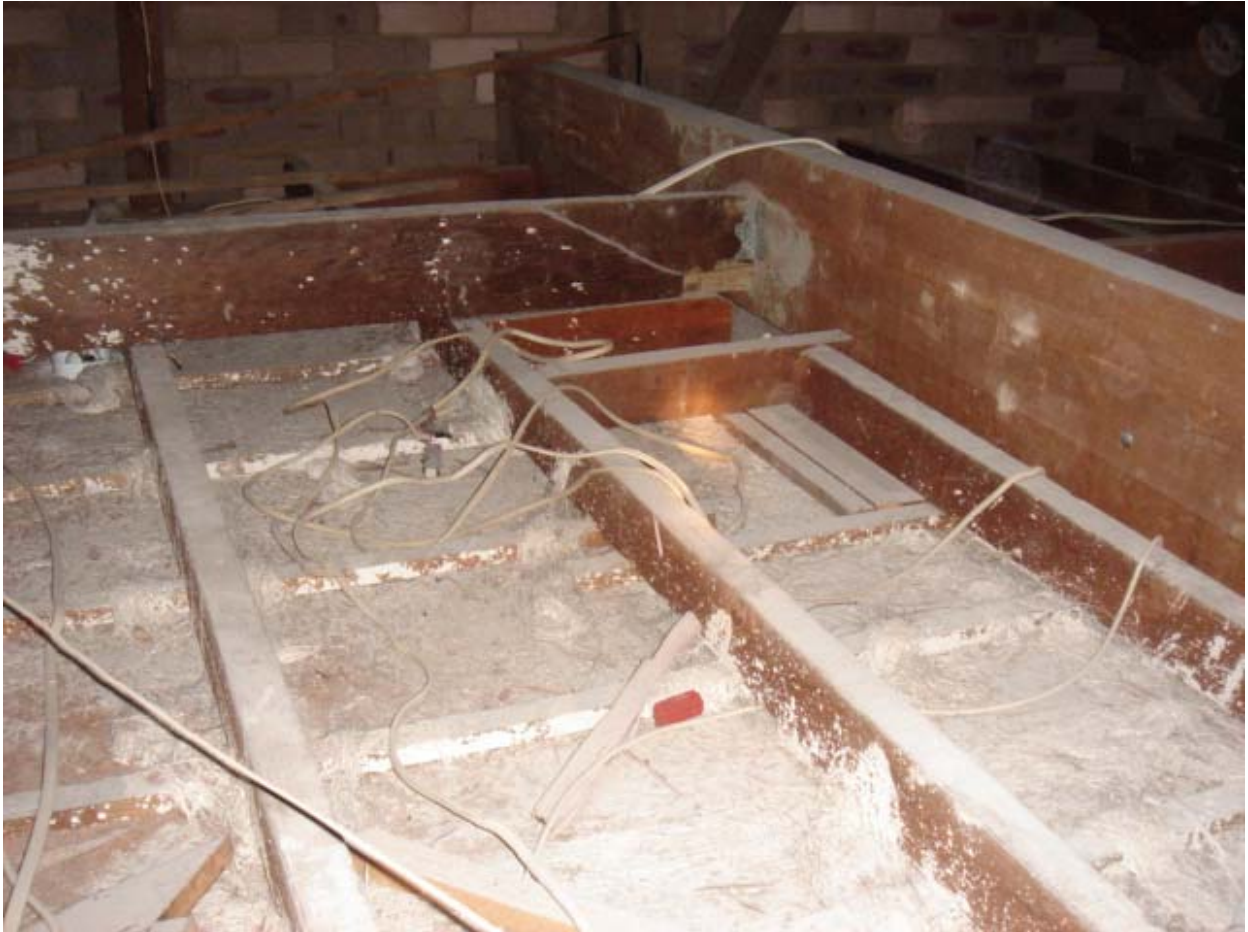
Photo 4.

6. The electrical wiring requires some repairs:
- i) Electric cables in the ceiling cavity have been installed across the ceiling joists in an unsafe manner and contrary to standard wiring practice, a condition that presents a safety and fire risk and repair should now be undertaken by an electrician at which time further investigation of the wiring would be recommended to determine whether any other electrical defects are present. (See photo 4).
 - ii) The metal fuse box is corroding and requires restoration or replacement will soon be necessary.
 - iii) Exposed electric cables running below the rear balcony require concealment.

Electric cables in the ceiling cavity are unsafe because they have been installed across the ceiling joists contrary to standard wiring practice.

An electrician should now be engaged to rectify the above defects as soon as possible for safety purposes with costs being in the order of \$800 at which time further investigation of the wiring should be undertaken to determine whether any other repairs are required.

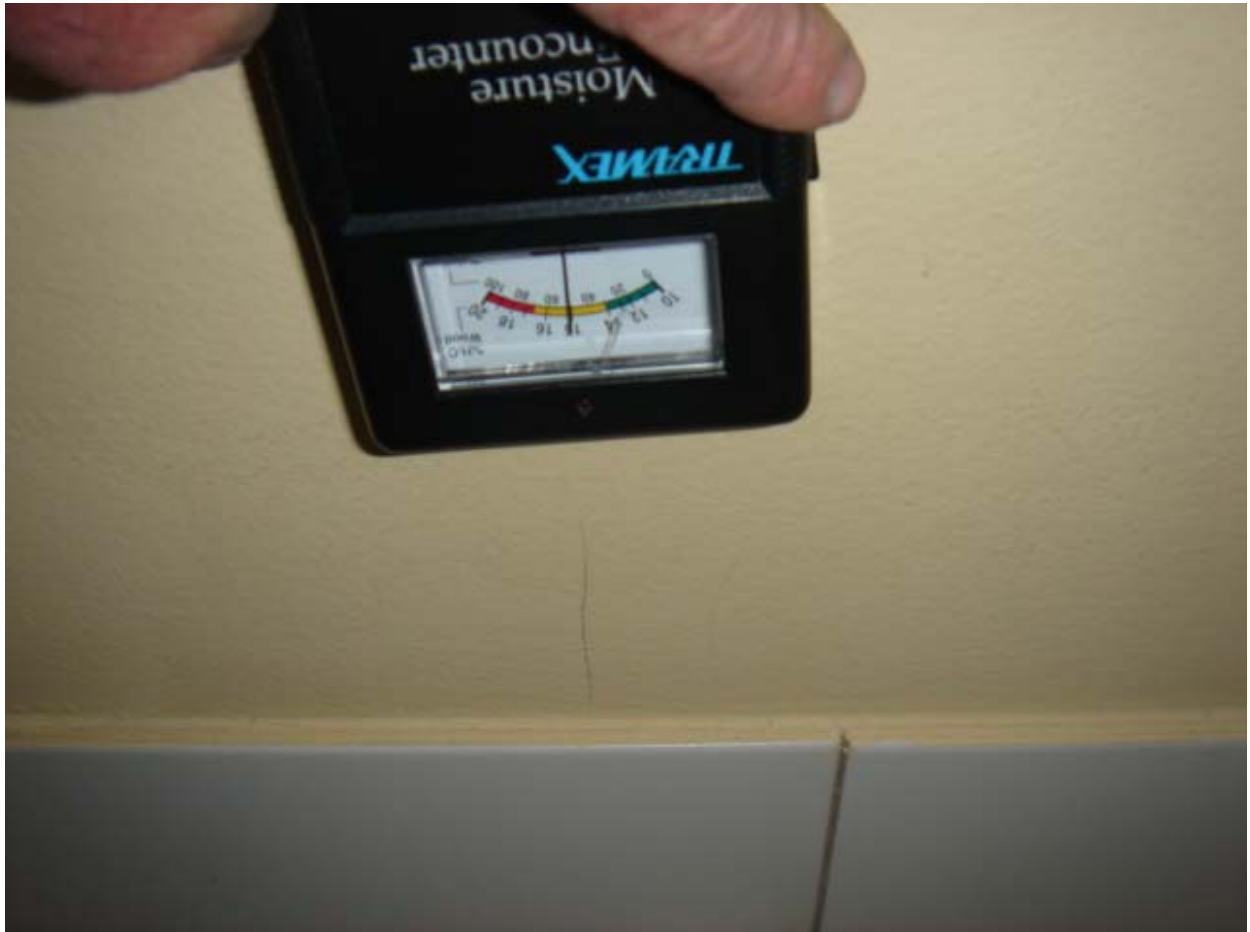
Photo 5.

3. Damp meter readings taken about the surface of the walls at the lowest floor level revealed a high level of moisture in the walls. (See photo 5).
4. Ventilation in the subfloor below the house is poor and seepage may accumulate on the ground during wet weather periods.

Damp meter readings taken along the surfaces of the walls in the rooms at the ground floor revealed a high level of moisture in the walls.

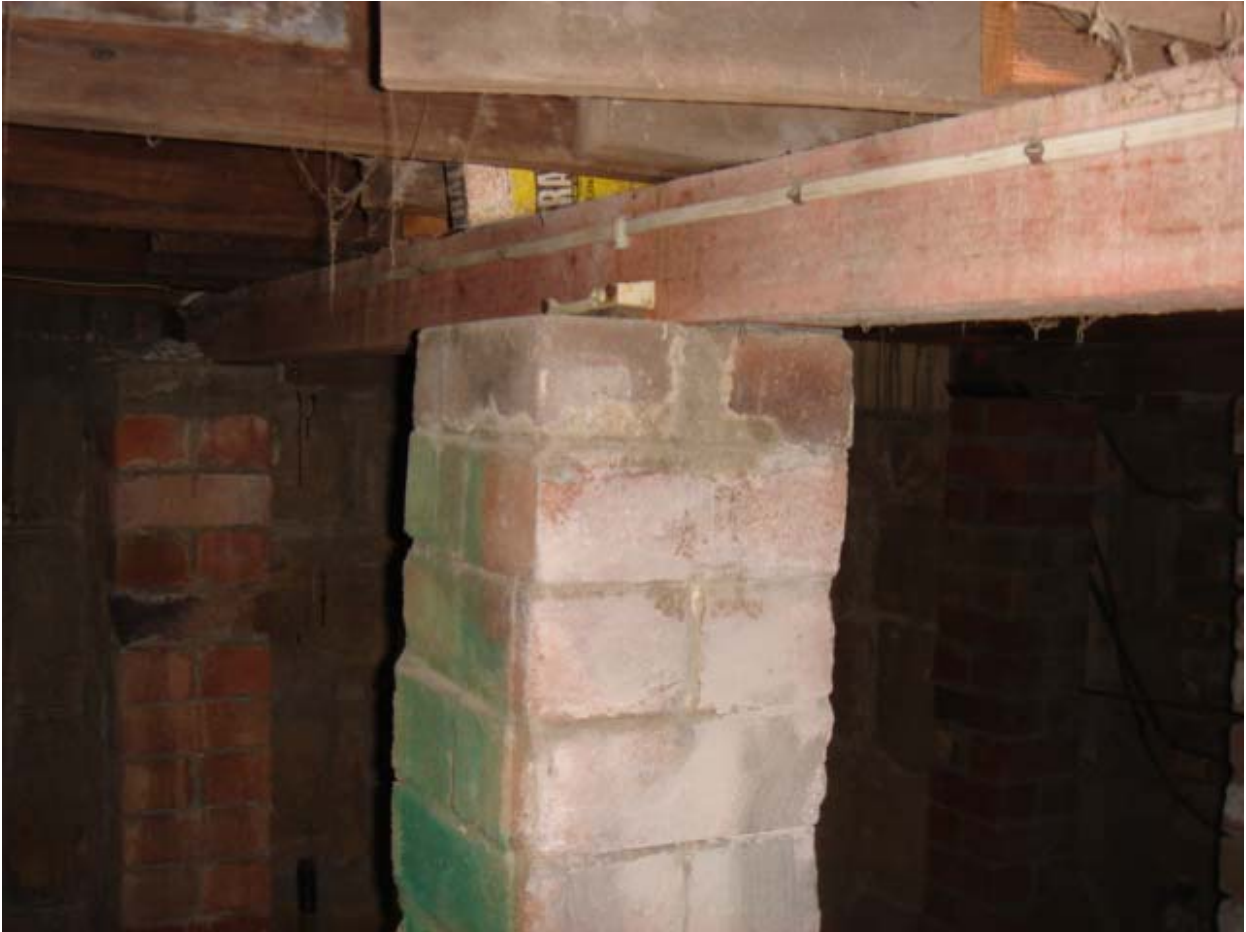
Photo 6.

No antcaps have been installed on top of the brick piers in the subfloor below the building for proper termite identification.
